Manhole Inspection Summary

Manhole # S09YY1008MH

Location Address: **2707 WHITNEY AVE**

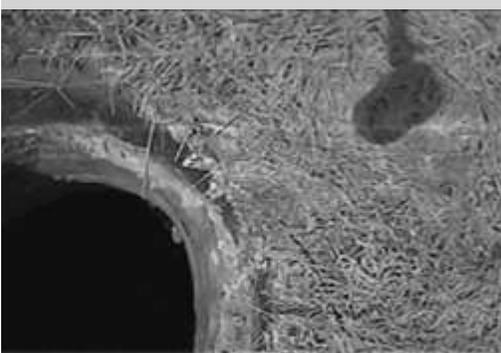
Frame Offset: **2** (in.) Condition: Sound Cracked Leaks

frame offset

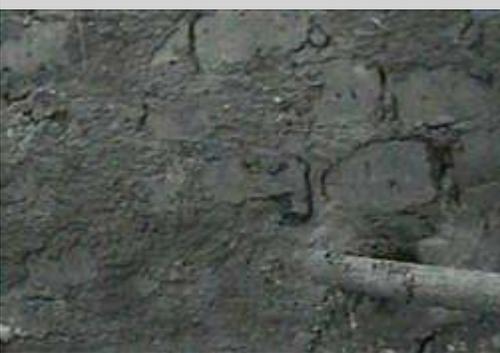
Infiltration: None **Joint** Cracks **Mortar** Roots Wall

corbel

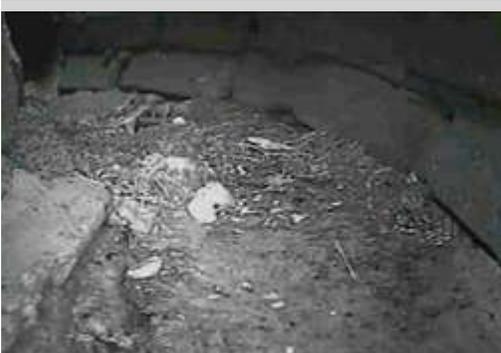
Condition: Sound Cracked Root Intrusion Deteriorated Leaks **Debris**

Defect

debris in channel

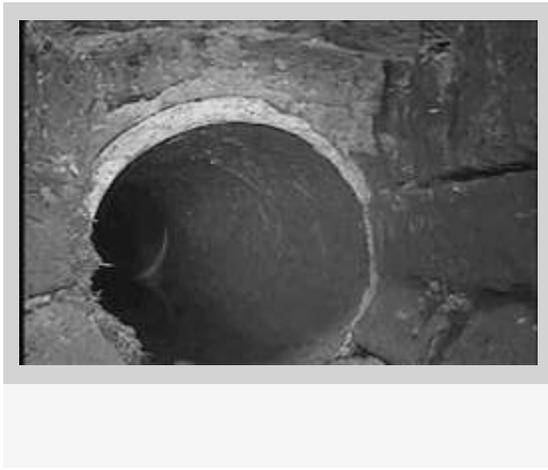
**8 in. Circular Gravity Sewer
Pipe Out @ 12 O'Clock**

Infiltration: **Evidence** Pipe Seal Cond: **Unknown**
